## Investigation of a flooding claim

# Investigation of a flooding claim

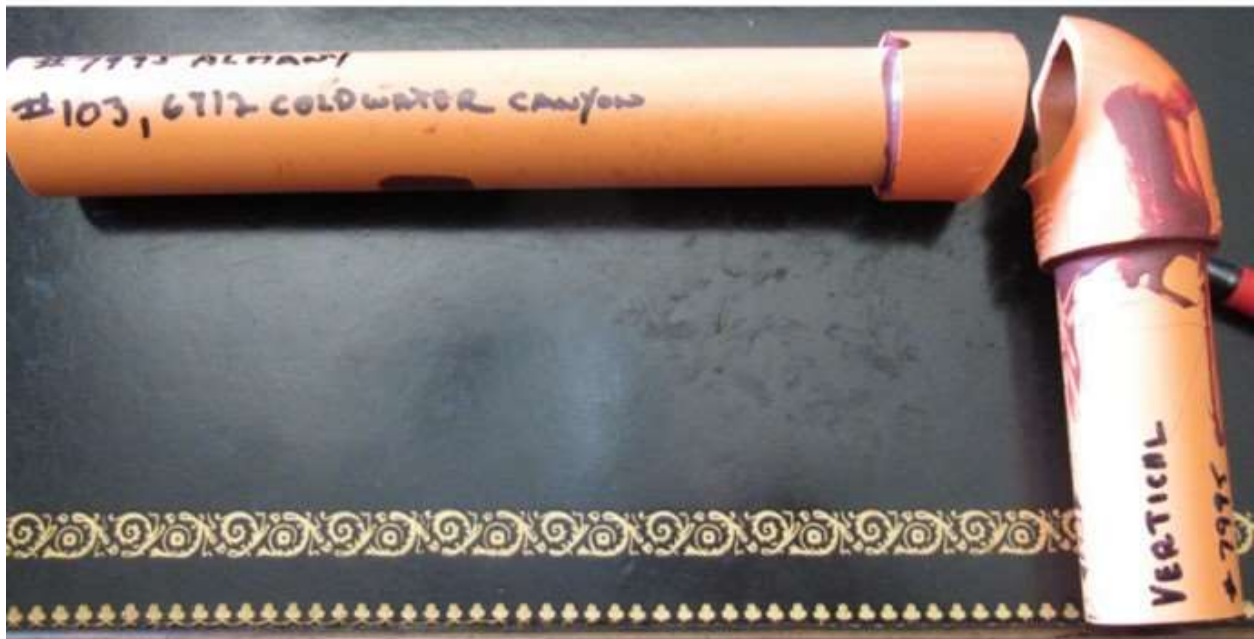
**FAILURE OF A CPVC 90-DEGREE ELBOW**

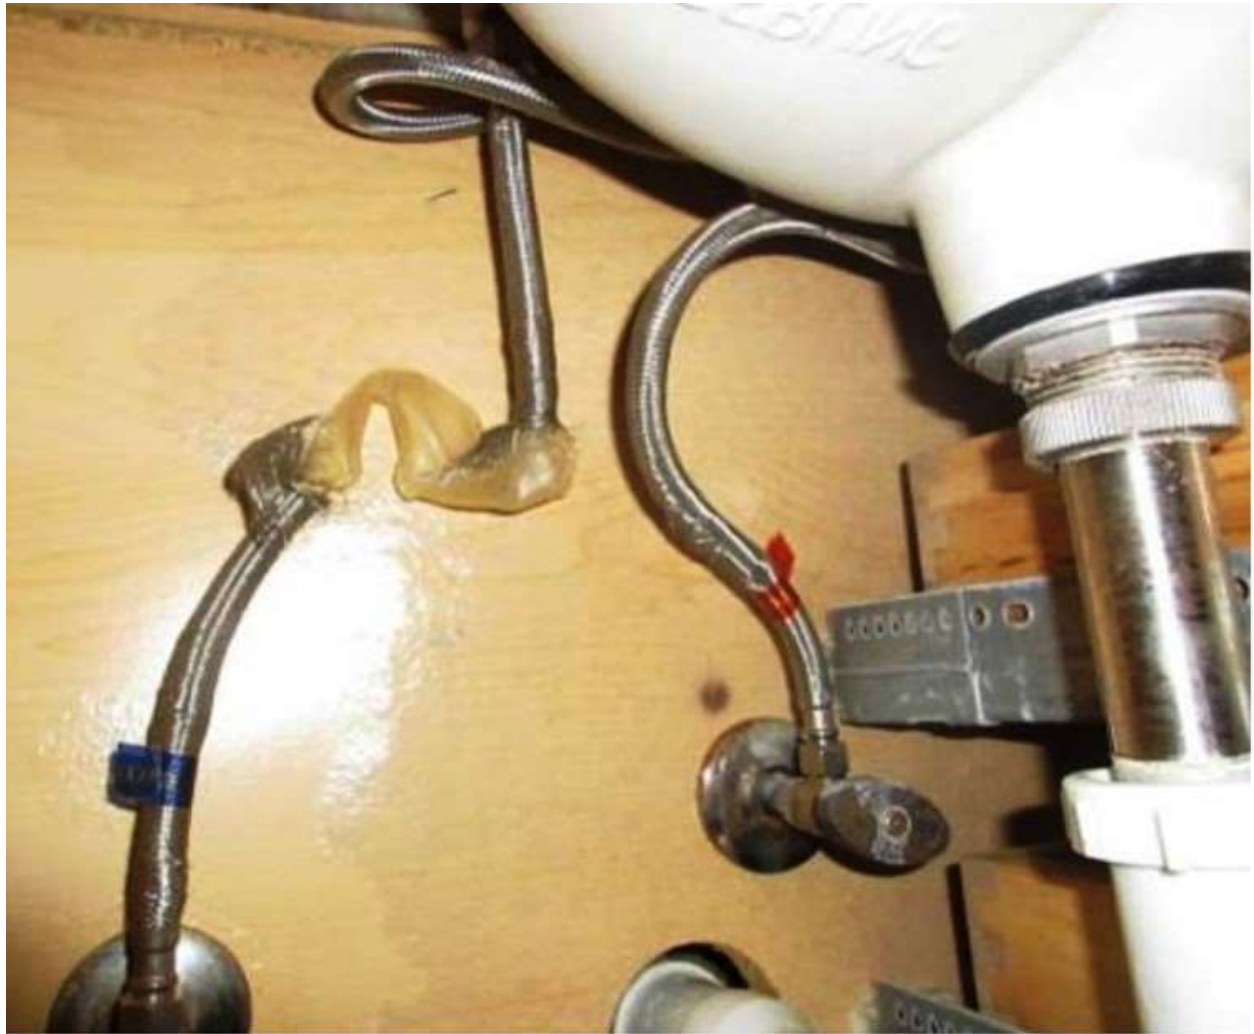
**FAILURE ANALYSIS OF A STAINLESS STEEL BRAIDED WATER LINE**

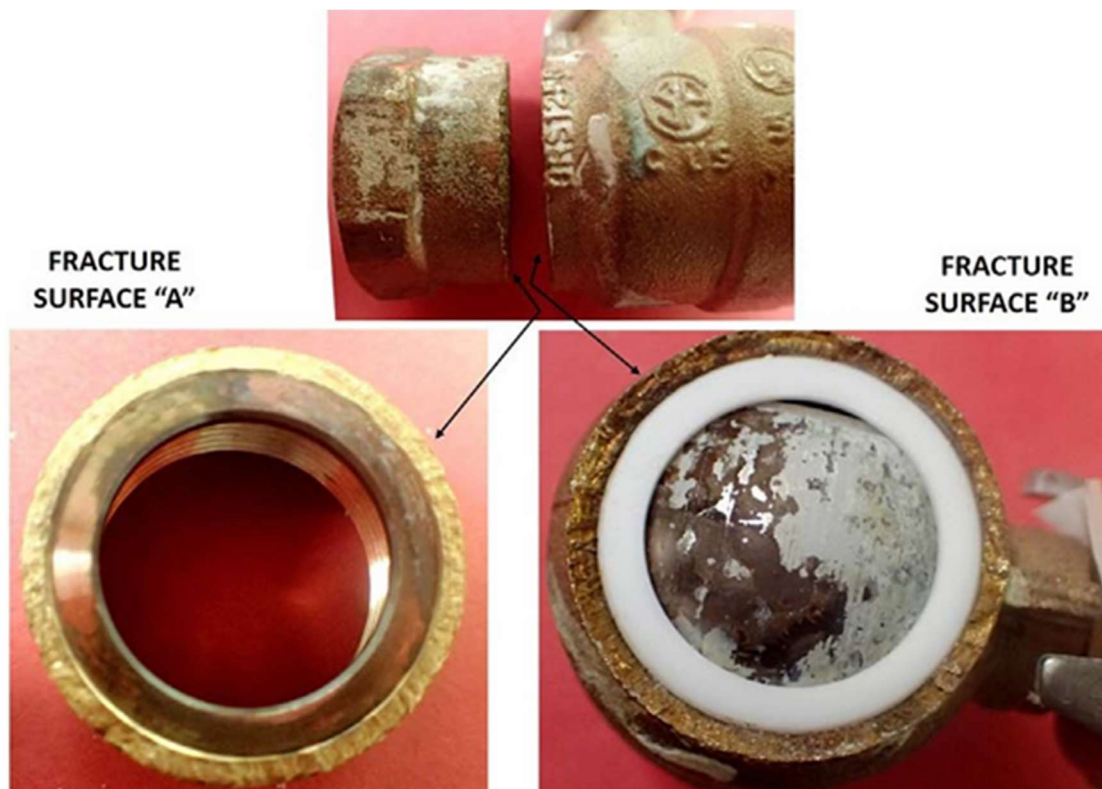
Failure of a brass valve

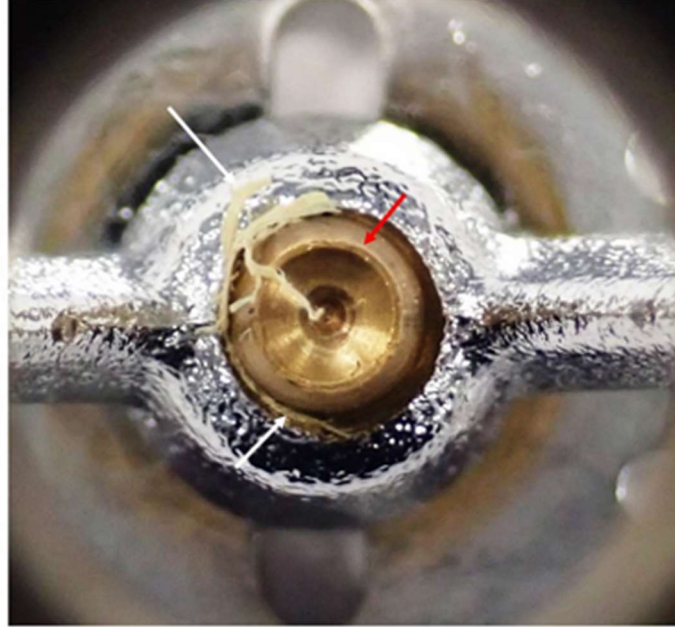
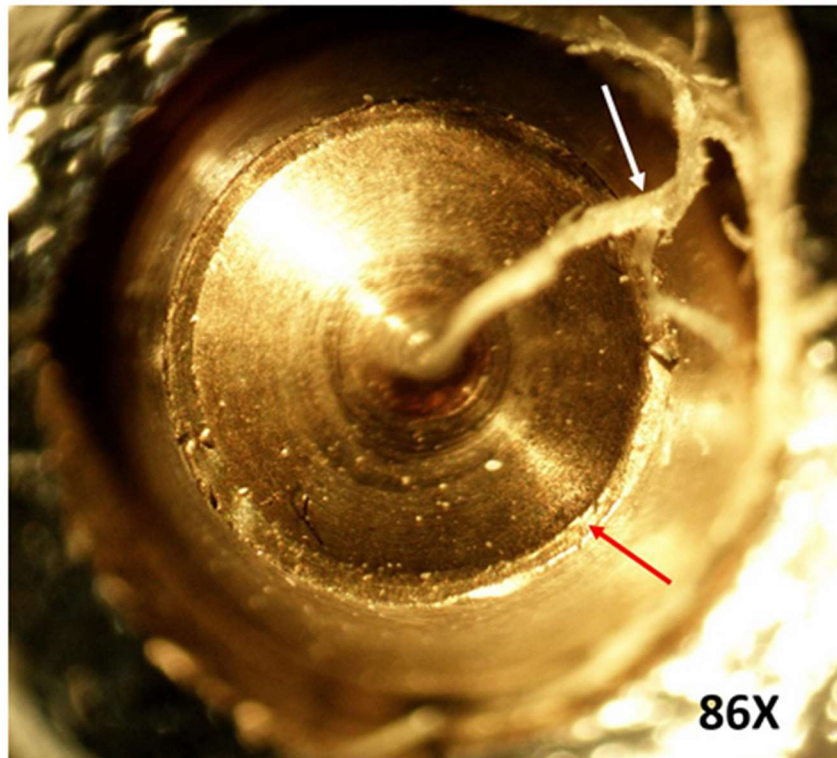
The brass load screw of Sprinkler Head 3, indicated by the red arrows, does not show any deformation nor cracking. The white arrows show fibers "trapped" in the threads of the load screw and the arms of the sprinkler.

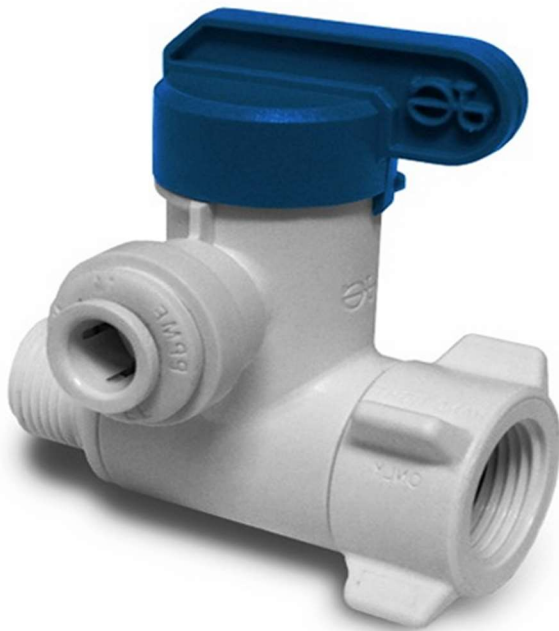
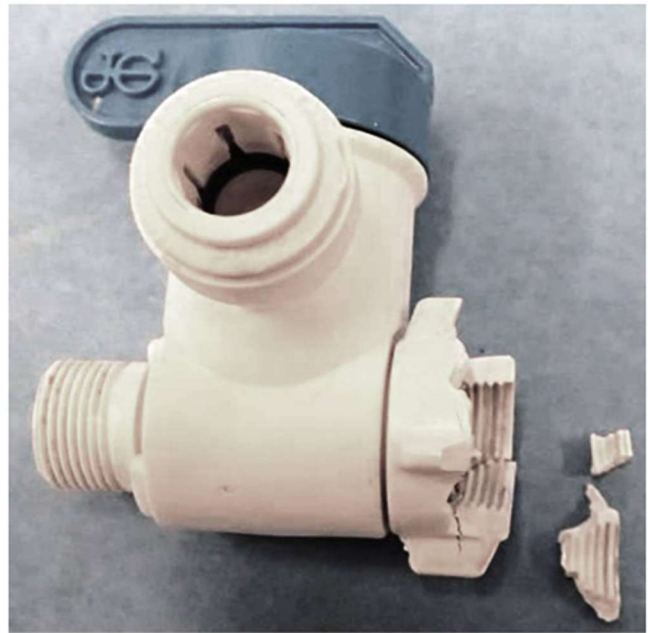
**FAILED "ANGLE STOP VALVE PASVPP2",  
3/8", FROM "JOHN GUEST<sup>®</sup>".**

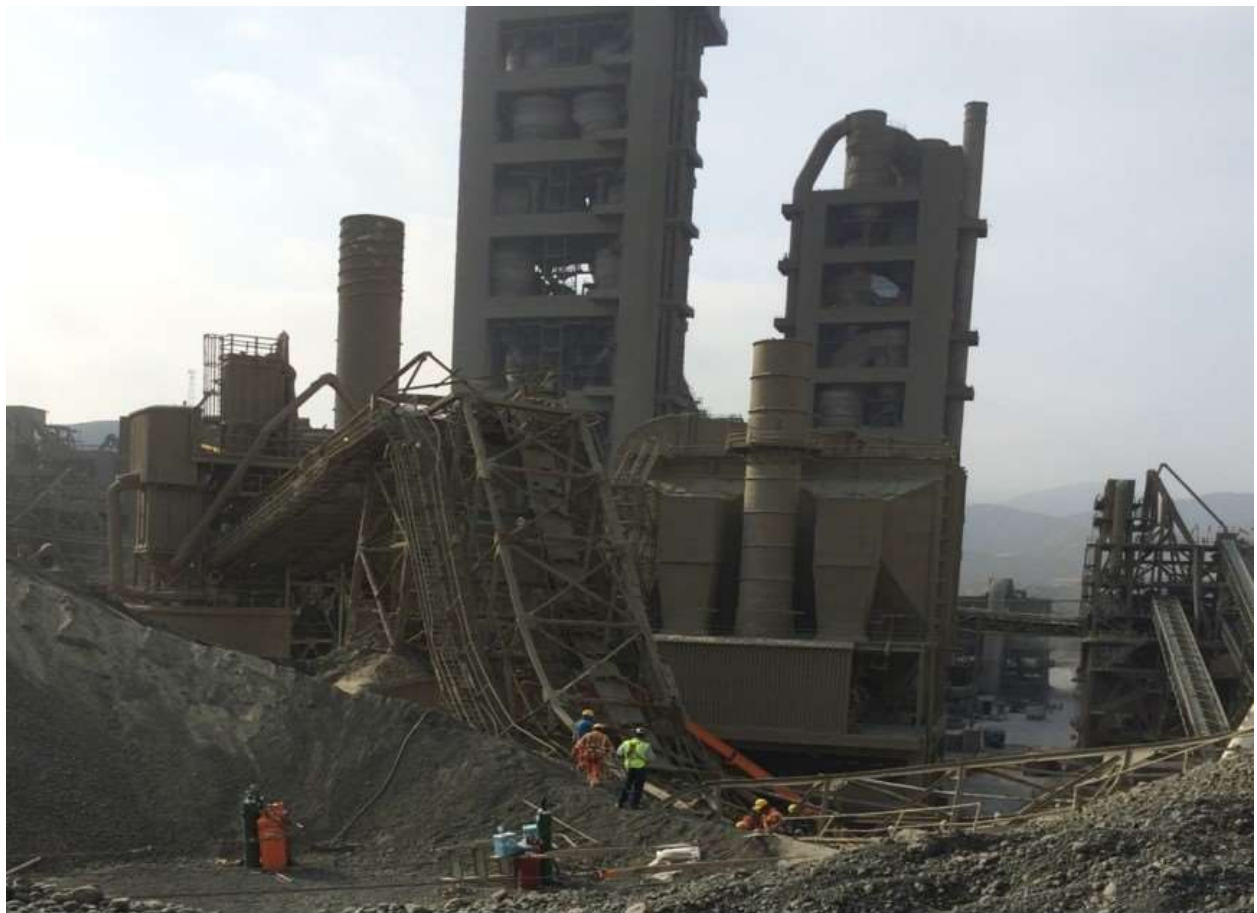
**INVESTIGATION OF THE COLLAPSE OF THE METALLIC STRUCTURE OF A CONVEYOR LINE**

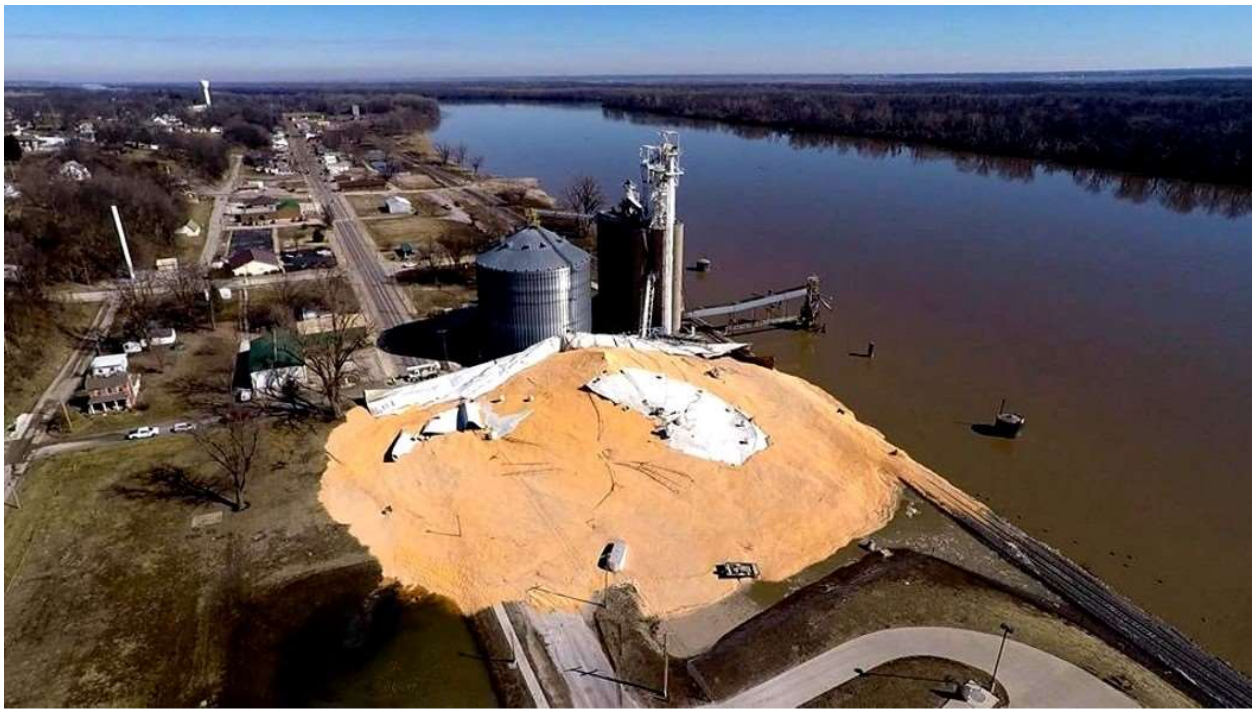
**INVESTIGATION OF THE COLLAPSE OF A GRAIN BIN**

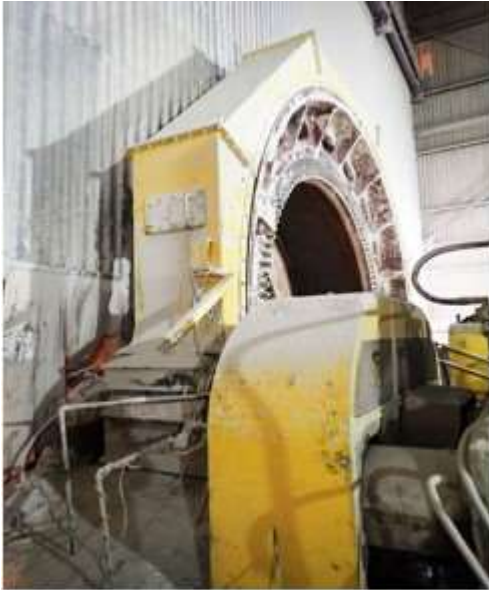
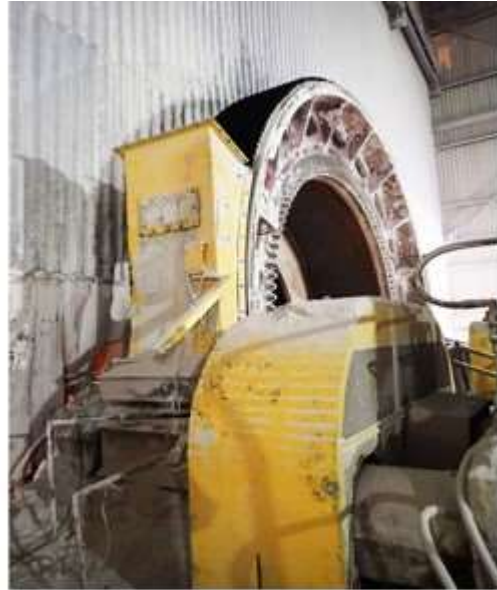
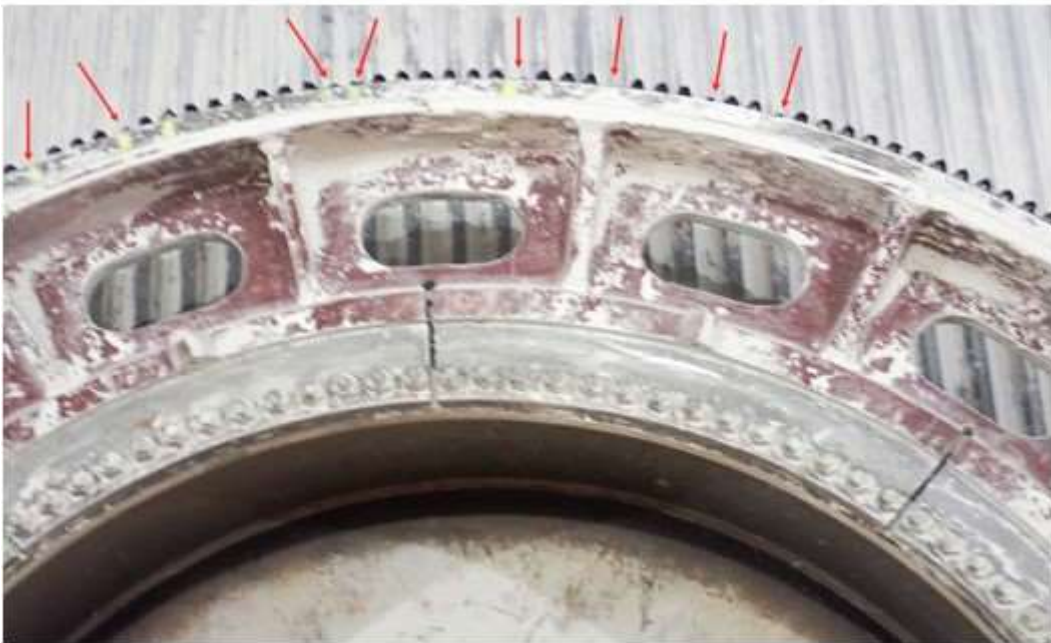
**FAILURE OF A MILL RING GEAR IN A CEMENT PLANT**

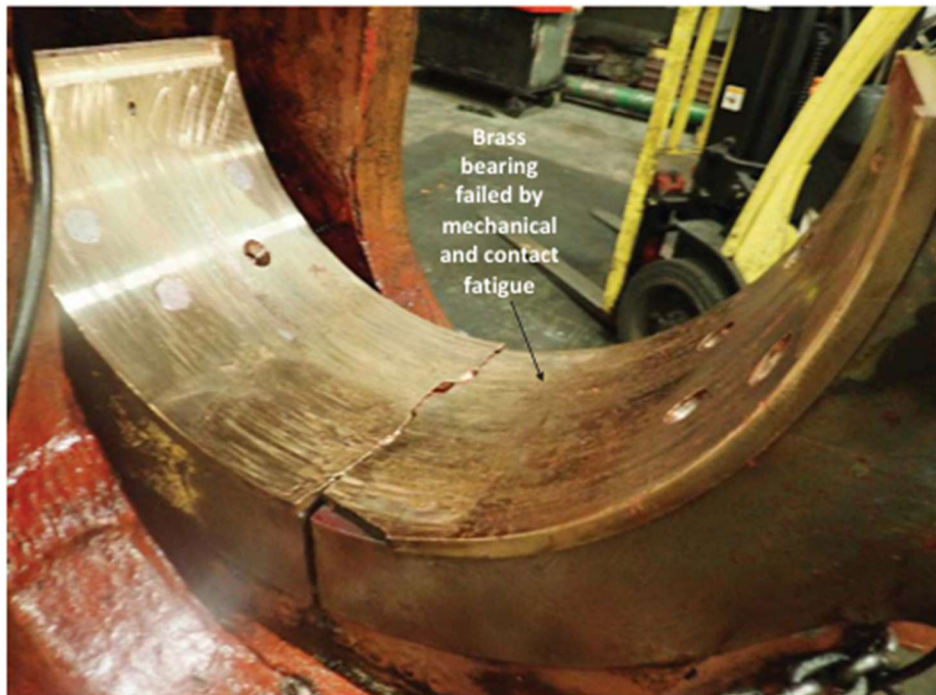
Brass  
bearing  
failed by  
mechanical  
and contact  
fatigue

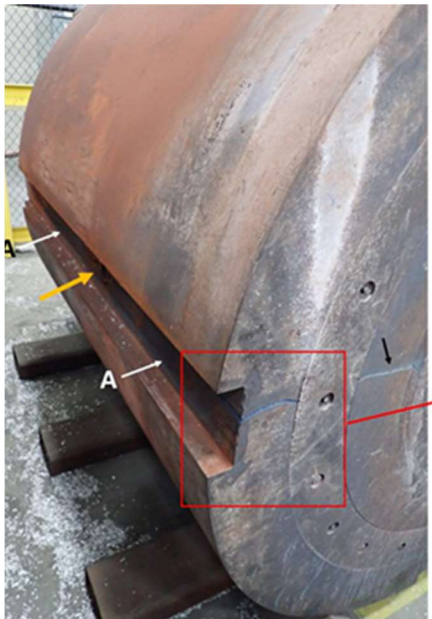
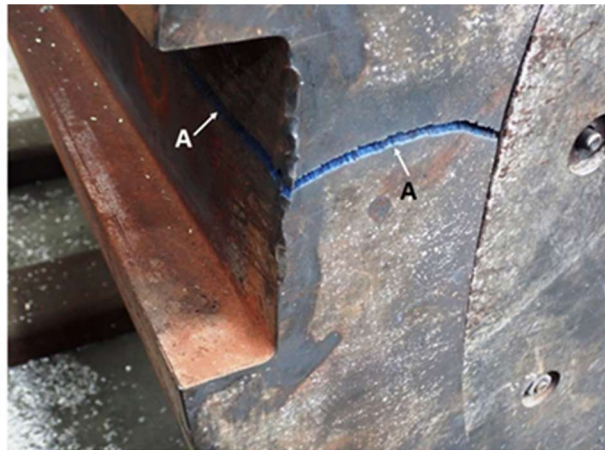
The fracture A is larger and deeper than the fractures B and C which indicates that the cracking/fracture A was the first one generated by fatigue.

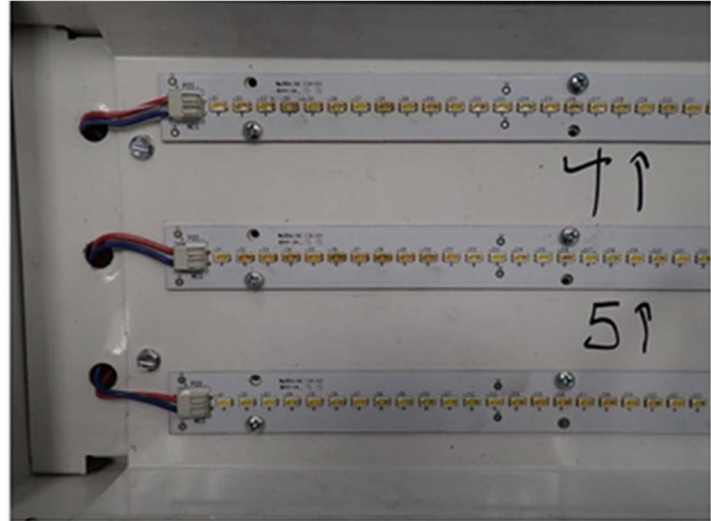
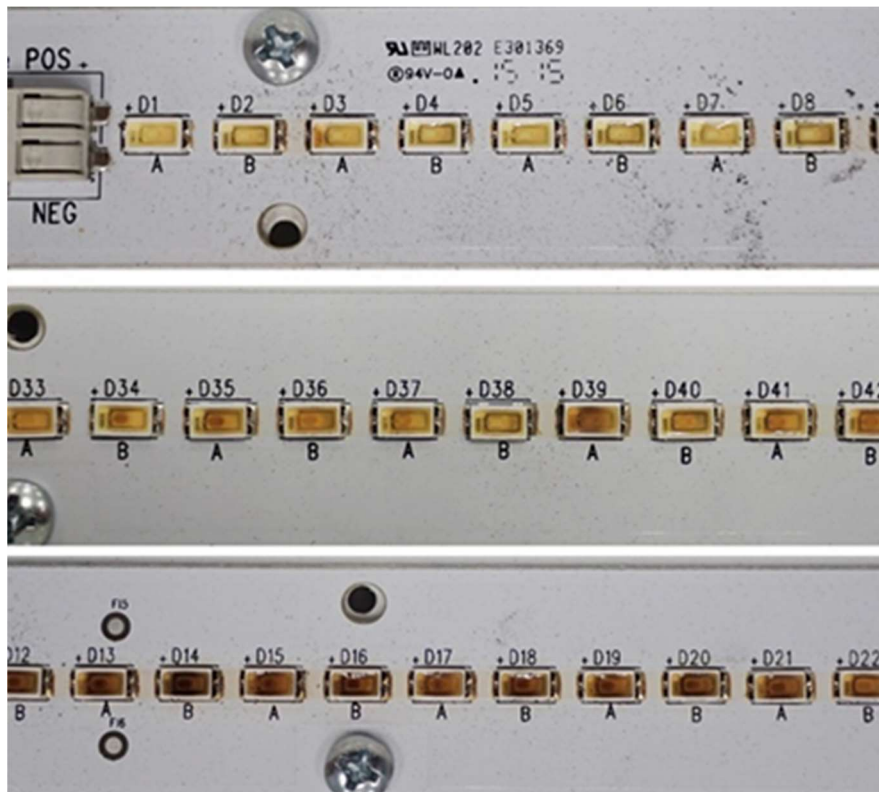
There is not any sign of corrosion (absence of white corrosion products on the galvanized mild steel screws as well as absence of rust in the screws and the mild steel housing) which indicates that the black deposits and the environment where the LED lamp was operating are not corrosive.

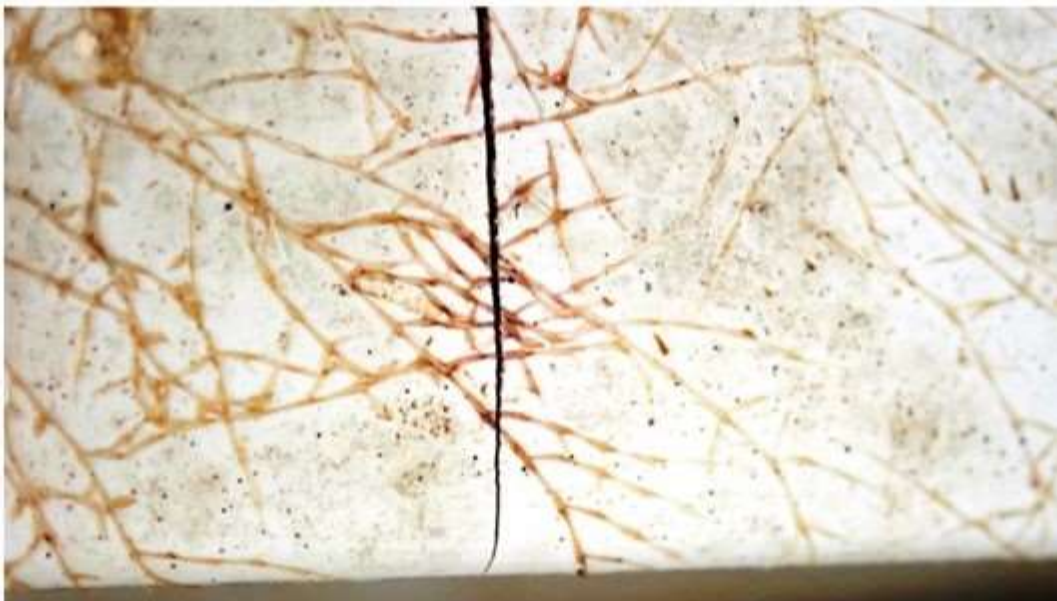
**FAILURE ANALYSIS OF THE GEALCOAT HULL OF A PLEASURE BOAT**

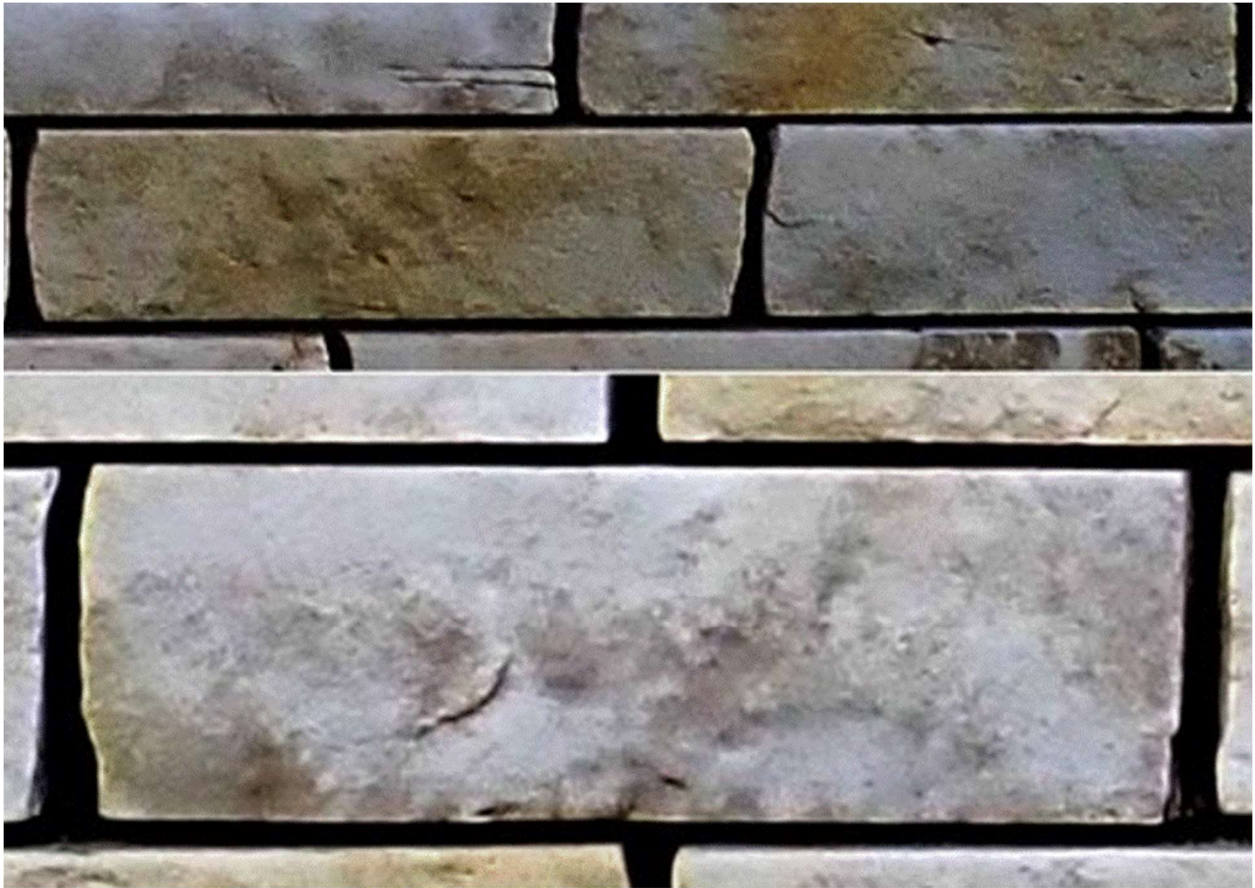
**INVESTIGATION OF THE STAINING IN NATURAL STONE BRICKS**

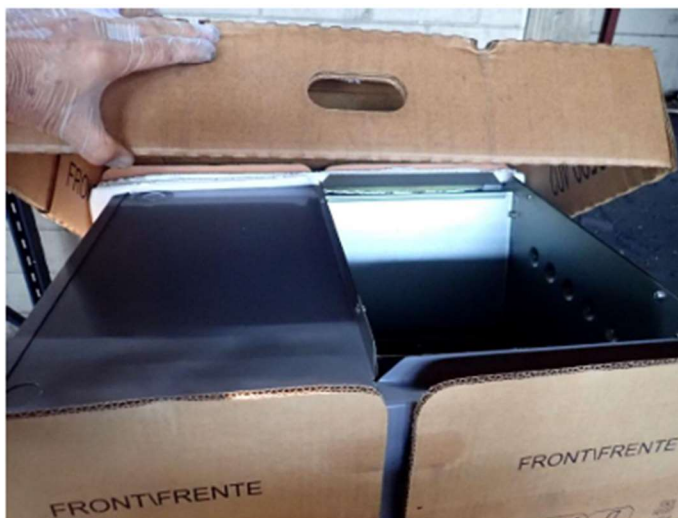
Carboard boxes containing furnaces. Photographs taken after a fire. The boxes show soot.
