## Investigation of a flooding claim

# Investigation of a flooding claim

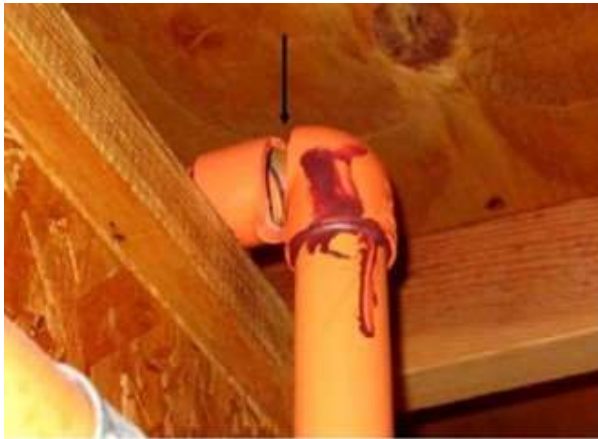
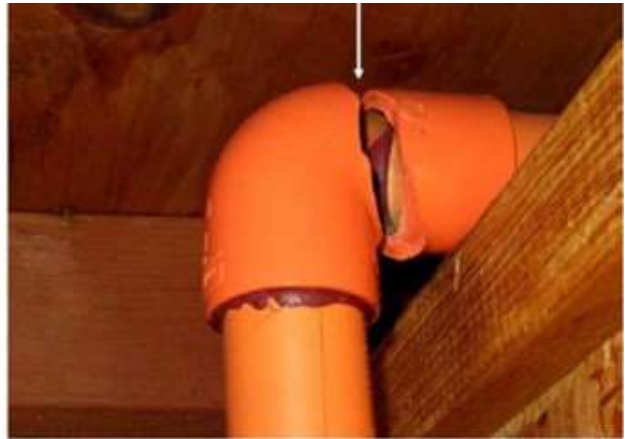
**FAILURE OF A CPVC 90-DEGREE ELBOW**

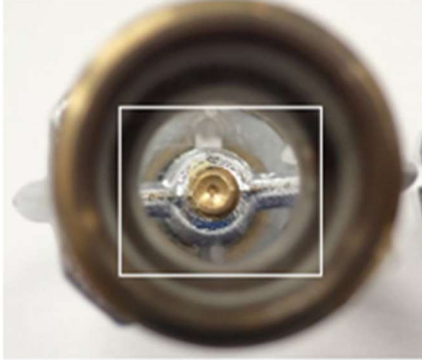
The brass load screw of Sprinkler Head 3, indicated by the red arrows, does not show any deformation nor cracking. The white arrows show fibers "trapped" in the threads of the load screw and the arms of the sprinkler.

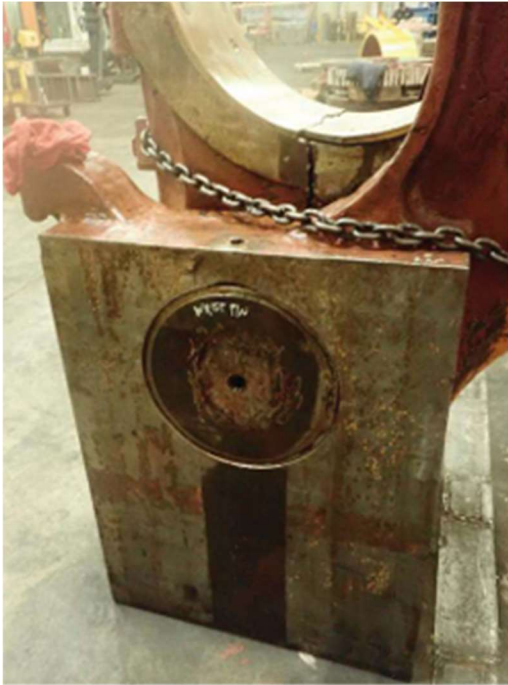
WRIST P/N SIDE

Brass  
bearing  
failed by  
mechanical  
and contact  
fatigue

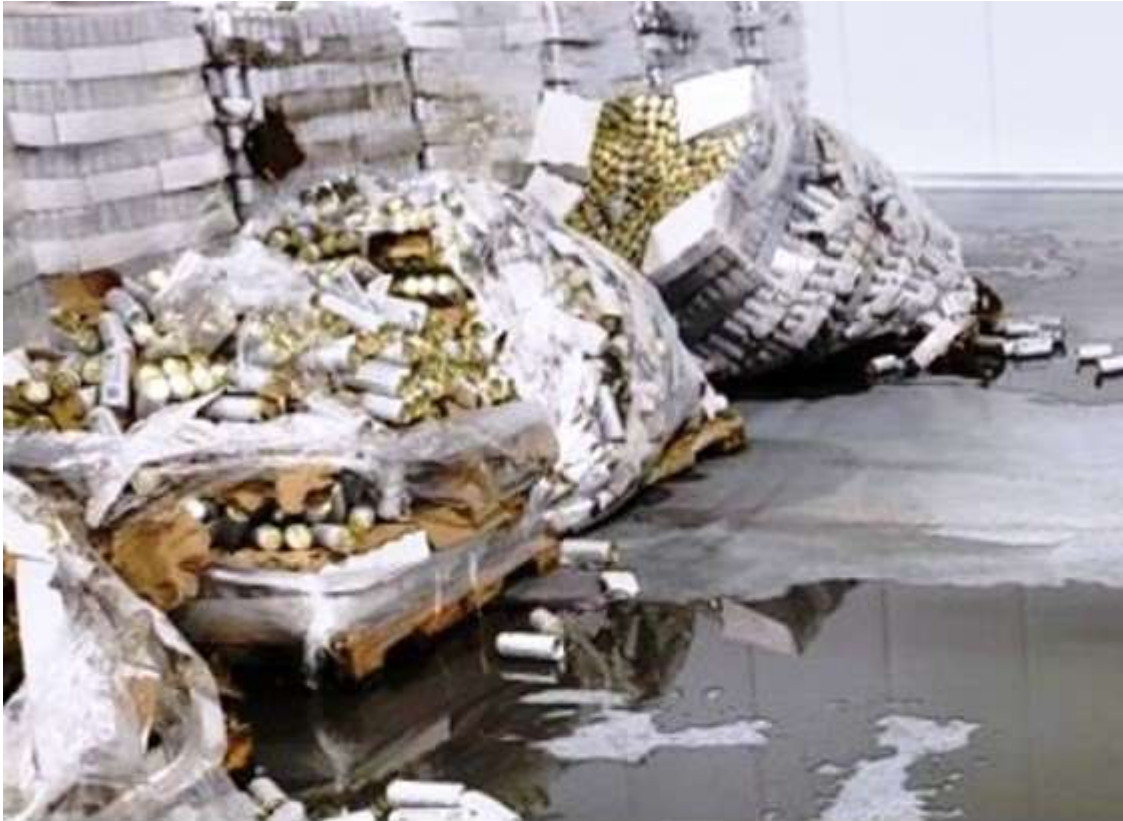
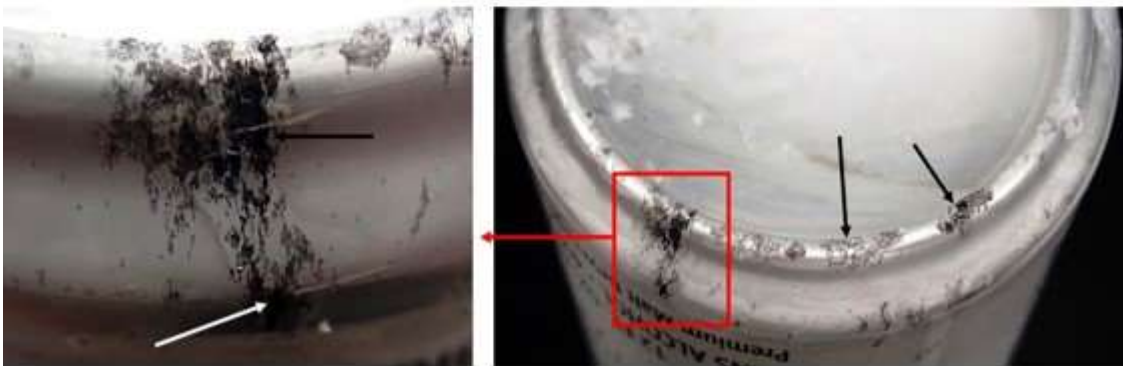
**FAILURE ANALYSIS OF ALUMINUM CANS**

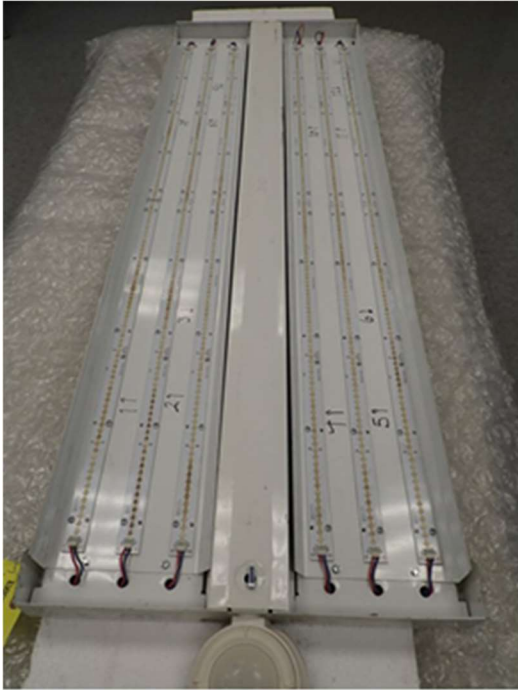
## Failure analysis of LED lamps

There is not any sign of corrosion (absence of white corrosion products on the galvanized mild steel screws as well as absence of rust in the screws and the mild steel housing) which indicates that the black deposits and the environment where the LED lamp was operating are not corrosive.

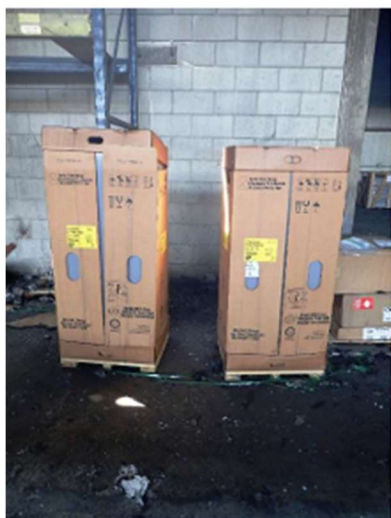
# Investigation of damage caused by soot generated during a fire

Carboard boxes containing furnaces. Photographs taken after a fire. The boxes show soot.

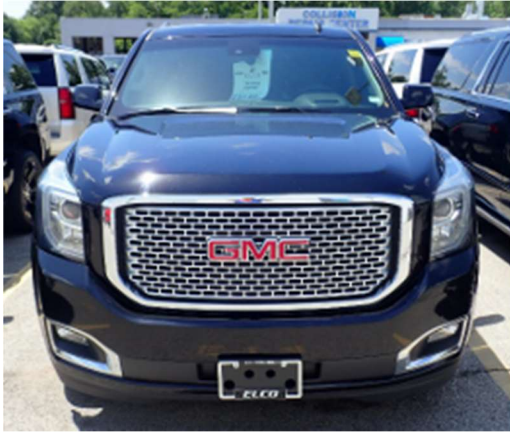
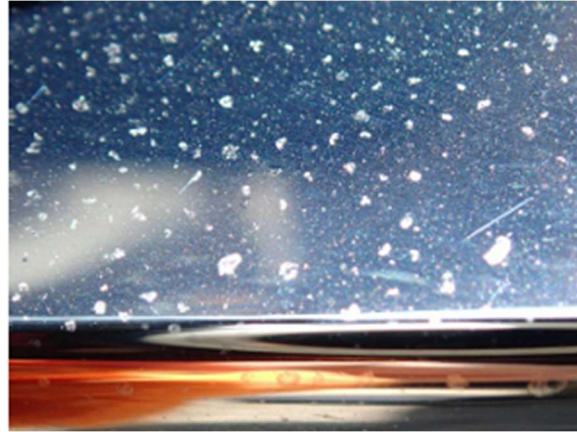
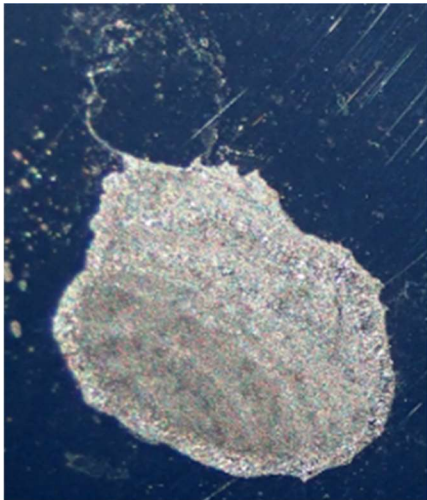
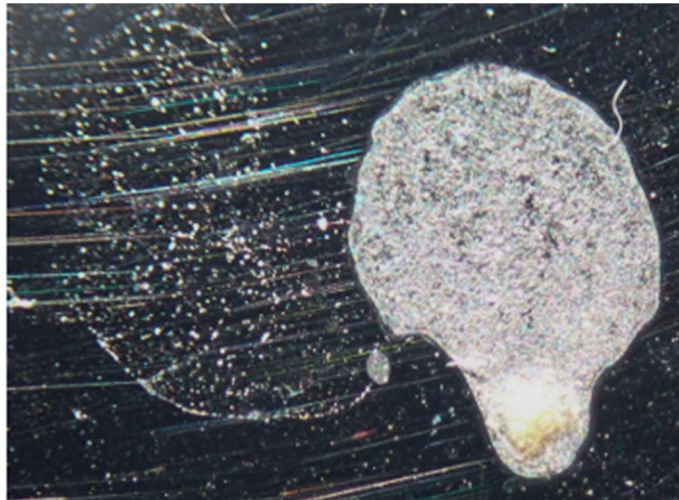
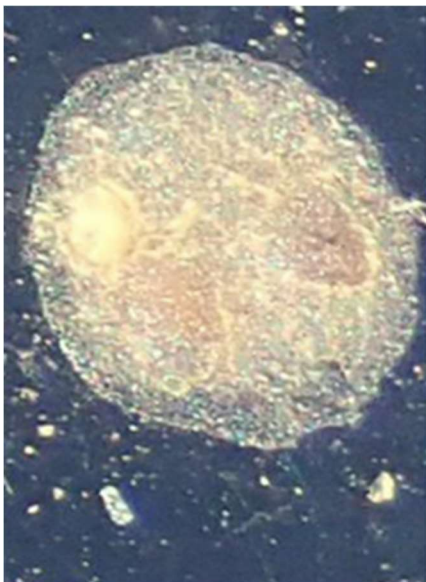
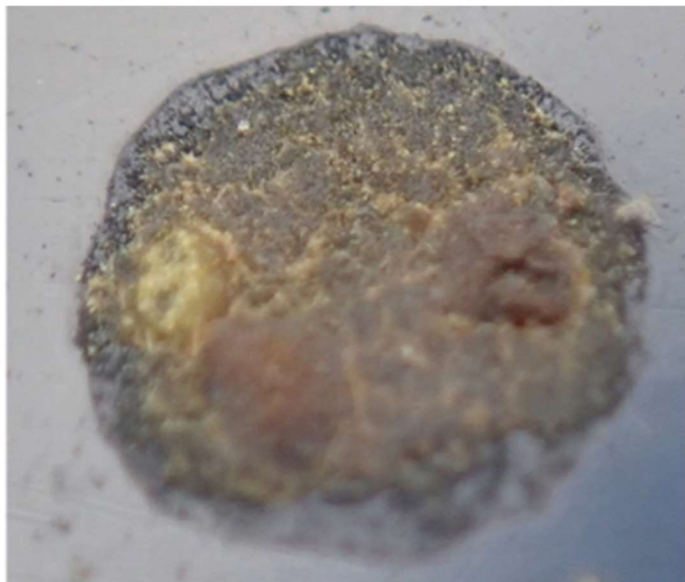
## Investigation of damage observed in vehicles at a car dealership
